paper Chain

Implementation of Circular Case 2
D5.3 - February (M33)

WP5, Task 5.3

New Market Niches For the Pulp and Paper Industry Waste based on Circular Economy Approaches

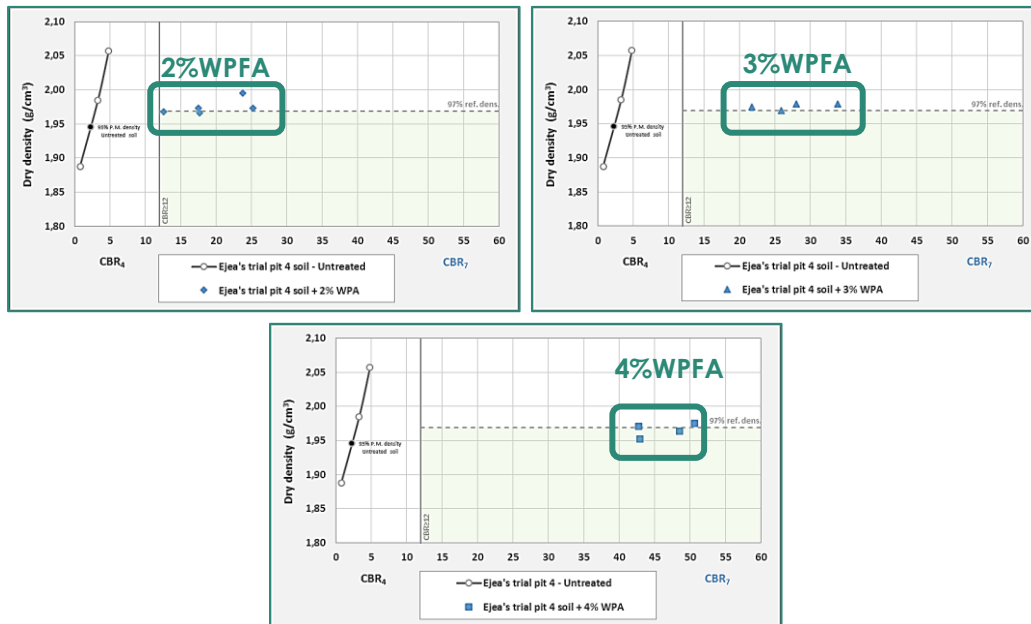
FIGURE 4. CBR soak test at 7 days on Boalares soil samples

All dosages reached the necessary CBR value for considering the soil as S-EST2 type (CBR>12) but 2% WPFA content was discarded in order to adopt a more reliable working formula (3%) for the first trial with this kind of stabiliser.

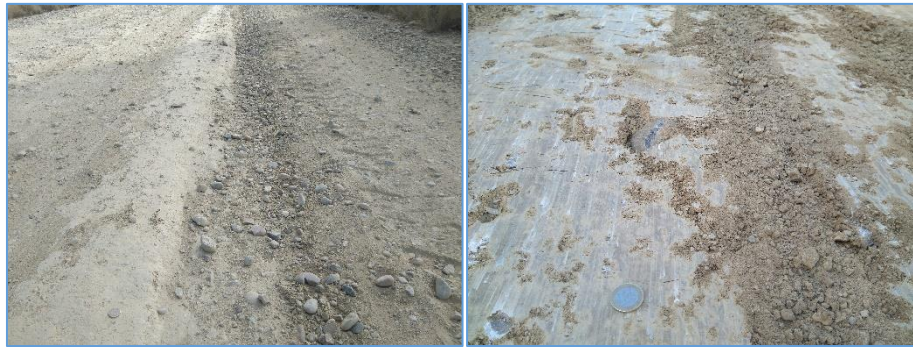
FIGURE 6. Original surface (left) and surface after gravel removing

As mentioned, the first step of the execution was to remove the layer of gravel ripping and digging 10 cm of the thickness of the path. The ripper device of a bulldozer and a light digger was used for this task.

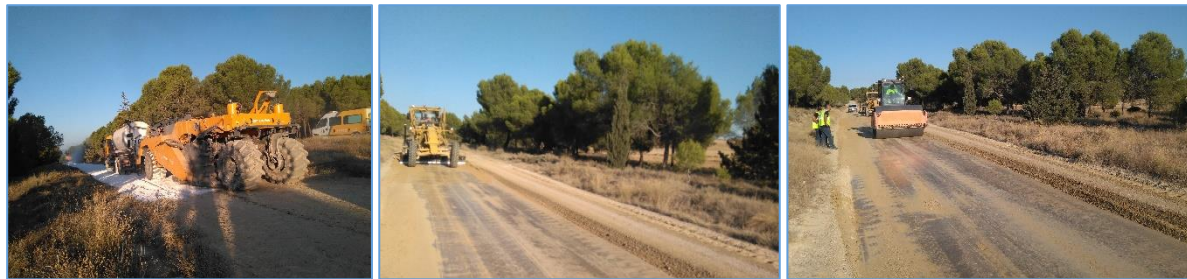
FIGURE 7. Soil stabilisation process: 3% WPFA dosing and mixing, levelling and compacting

A dosing machine for powdery materials was employed to spread out the accurate amount of WPFA needed to fit the working formula. Then, the stabiliser machine mixed the WPFA with 25 cm of underlying soil meanwhile the optimum water content was being injected. Behind the mixer, a vibratory roller pre-compacted the soil, a grader levelled the layer til the correct thickness and, the roller again, finished the compaction procedure.

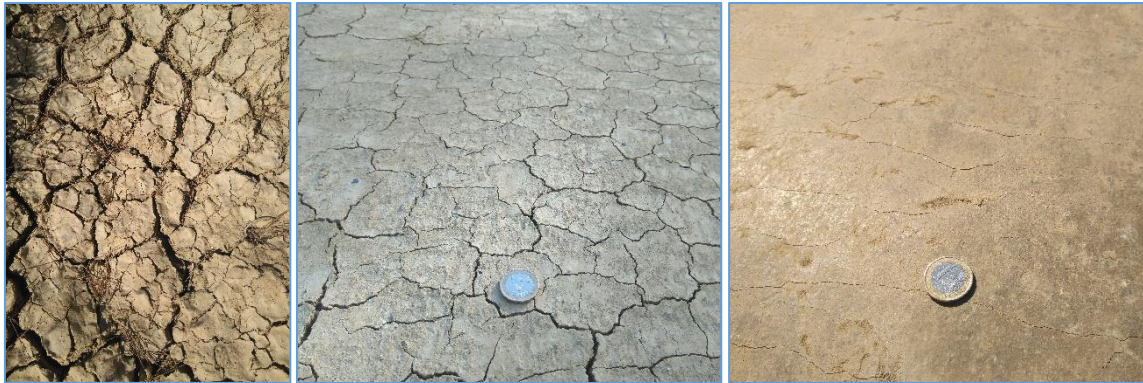
FIGURE 8. NATURAL AGED SOIL (1ST), WELL COMPACTED NATURAL SOIL AFTER RAINFALL (2ND) AND WPFA-SOIL STABILISED LAYER AFTER THE SAME RAINFALL (3RD)

As a curiosity, a rainfall event occurred a week after stabilisation and previous to the execution of the protection of graded aggregate layer. The performance of the pilot was excellent as shown in the following pics.

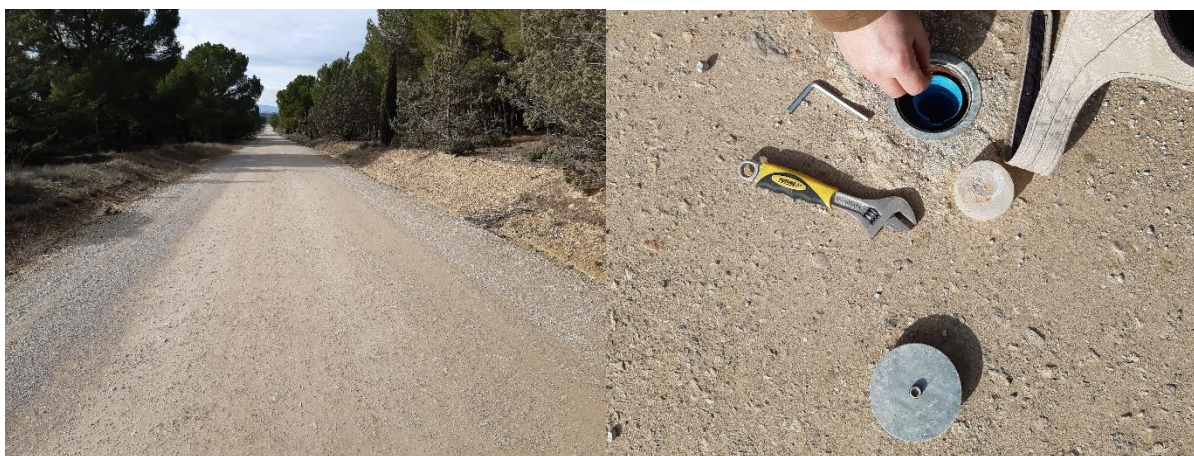
FIGURE 11: GENERAL VIEW OF THE ROAD ON JANUARY 2020 (R) AND CHECKING PIEZOMETERS (L)

- The surface was perfectly preserved, being smooth due to certain fines pumping after compaction of the graded aggregates.
- No deformation of the subgrade was detected or transferred to the graded aggregates surface.
- Some specific points were affected by water runoff due to the loose of drainage in the roadside, which has no connection with the stabilization works. This rework is going to be carried out by the municipality conservation team.

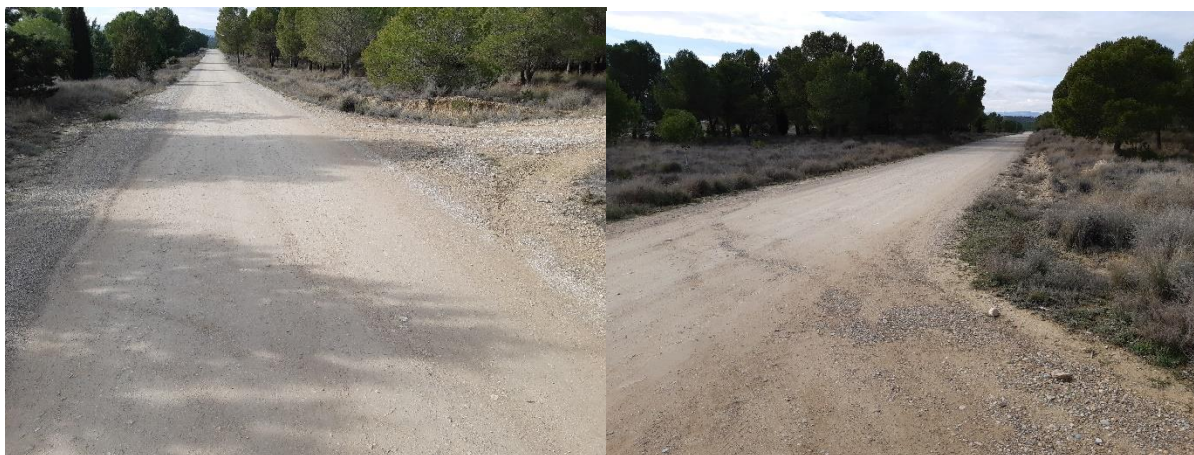
FIGURE 12: WATER RUNOFF AFFECTIONS DUE TO BAD DRAINAGE IN CERTAIN POINTS OF THE PILOT

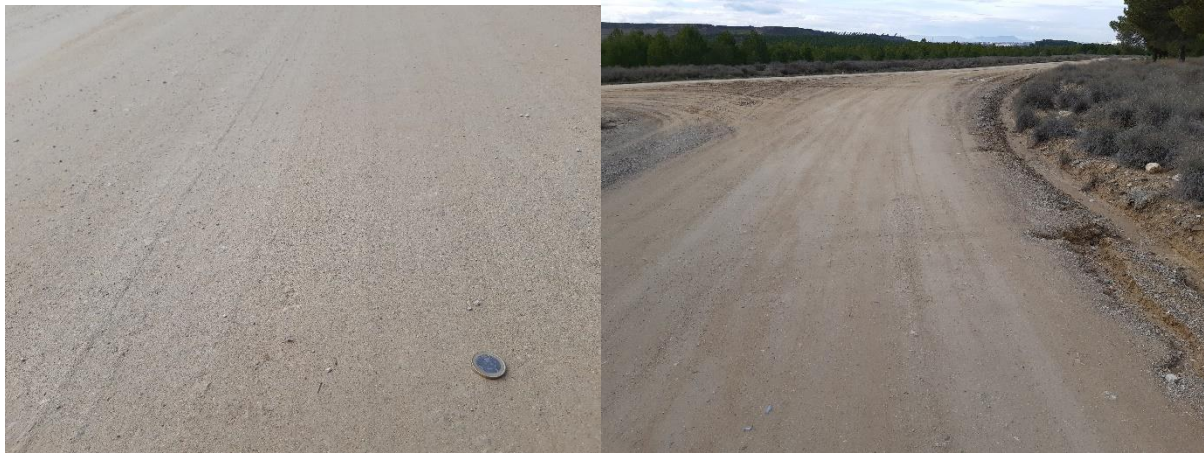
FIGURE 13: DETAIL OF THE SMOOTH SURFACE (R) AND CONNECTION WITH THE MAIN UNPAVED ROAD, BAD PRESERVED (L)

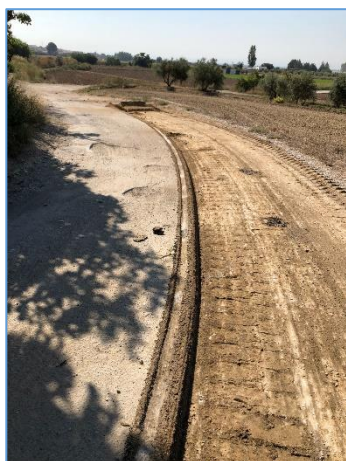
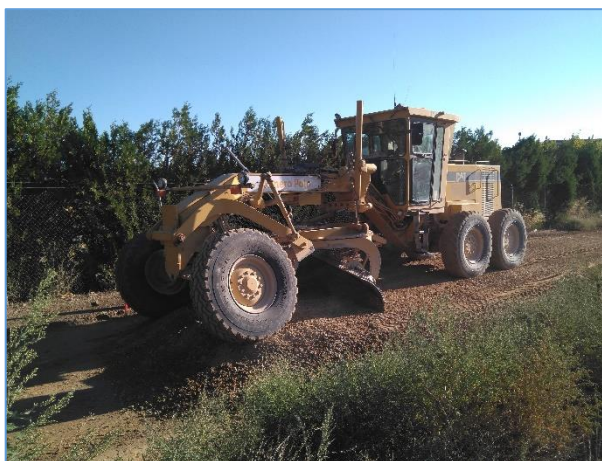
FIGURE 17. Milling procedure of the original surface. Levelling process of the borrow soil

Due to the heterogeneity of the materials in the path, it was necessary to remove 10 cm of the original surface layer. After that disposal process, several trucks hauled the borrowed pit soil, which was levelled and compacted simulating an *in situ* suitable soil for S-EST3 stabilisation purposes.

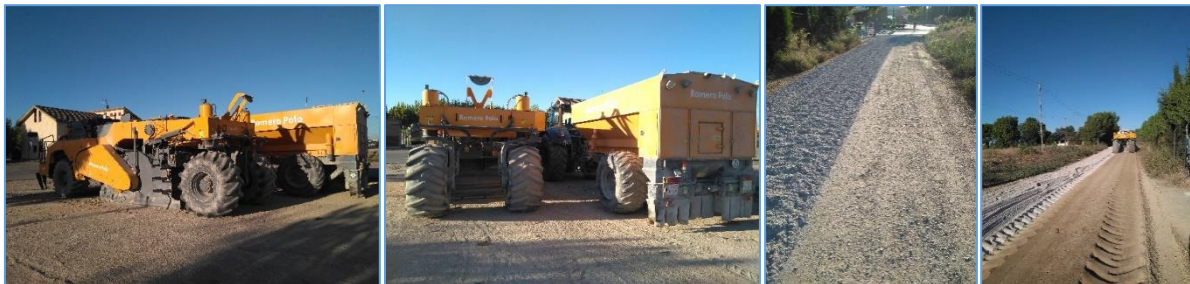
FIGURE 18. STABILISER AND DOSING MACHINERY (PROFILE AND BACK). DOSING 5% WPFA (DRY PROCESS). MIXING AND WATER INJECTION

As the pilot 1 (S-EST2), the WPFA was spread out by dry process and the machinery employed and the procedure was exactly the same. The only aspect that changed was the dose of WPFA and the amount of water.

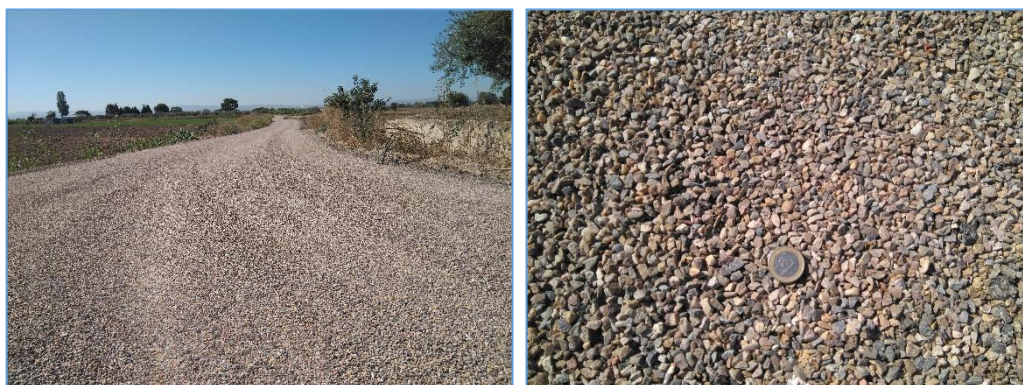
FIGURE 19. DOUBLE BITUMINOUS SURFACE DRESSING AND DETAIL VIEW

Immediately after the final compaction of the WPFA-soil, the emulsion-gravel treatment was laid out generating a protective surface layer.

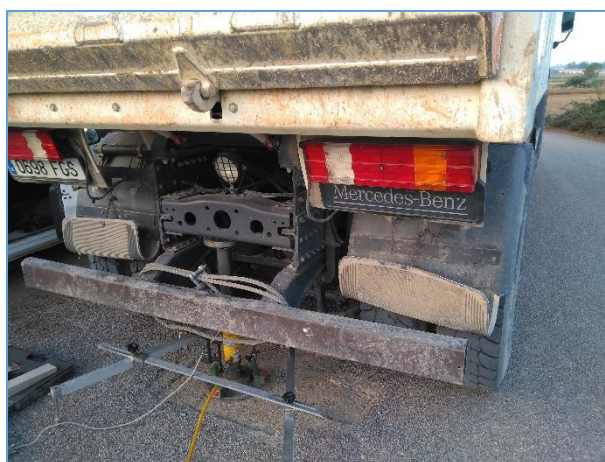
FIGURE 20. LOAD TEST (AFTER 14 DAYS)

TEST	ORIGINAL SOIL	REQUIREMENT	WPFA-STABILISED SOIL
Unconfined Compressive Strength at 7 days	N/A	at 98% MDD $\geq 1,5 \text{ MPa}$	at 98% MDD: 1,8 MPa ✓ (average)
Load test of plate soils at 14 days (diam=30 cm)	N/A	$E_{v2} > 60 \text{ MPa}$ for subgrade E1 $E_{v2} > 120 \text{ MPa}$ for subgrade E2 $E_{v2} > 300 \text{ MPa}$ for subgrade E3	$E_{v2} > 334 \text{ MPa}$ (average) <u>Improved subgrade E3</u>

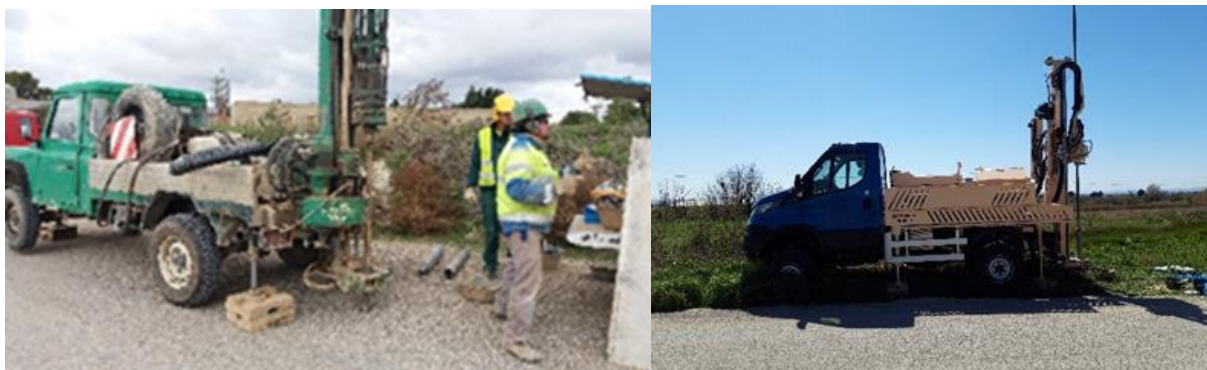
FIGURE 24. DRILLING FOR STABILISED SAMPLES AND INSTALLING PIEZOMETERS ALONG THE PILOT

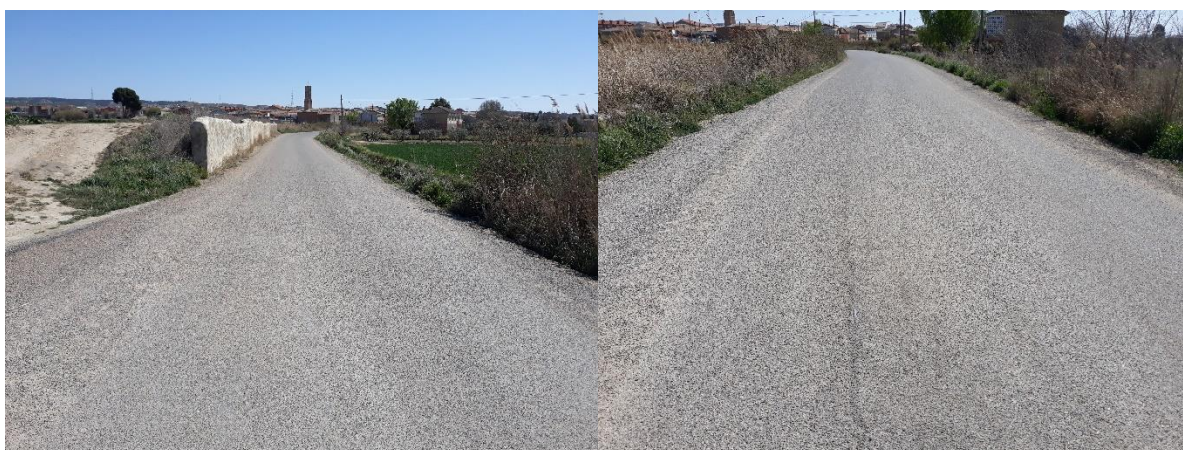
FIGURE 25. CEMENT STRETCH (L) AND WPFA STRETCH (R) SHOWING A JOINT

1st inspection 29 March 2019 (6 months after completion). Main findings: The road integrity was good. No damages related to a WPFA misfunction were identified. Some fails (potholes) were found associated with joints, although very punctually. An excess of aggregates from the surface bituminous dressing provoked an accumulation of loose aggregates in the junction between the local road and the originally unpaved road.

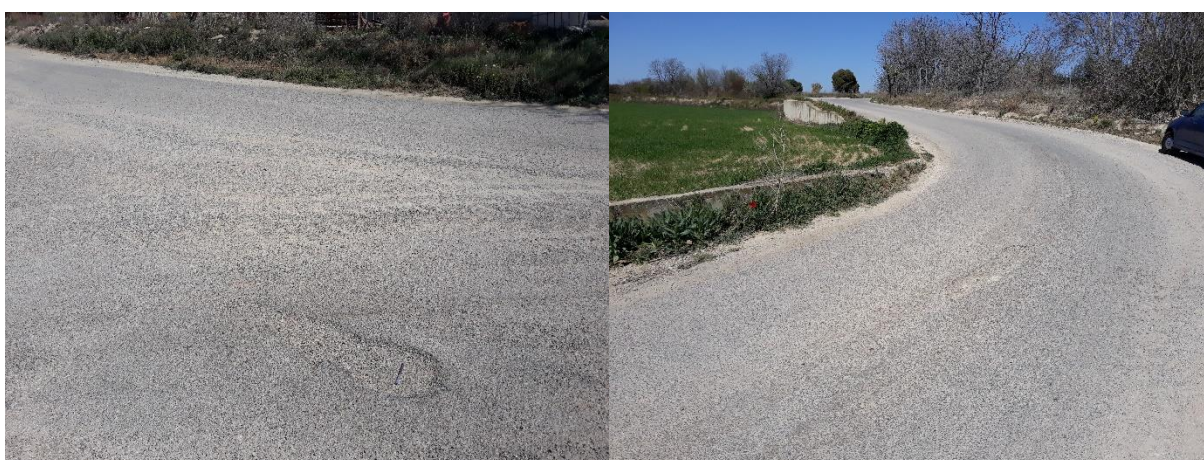
FIGURE 26. POTHOLE IN THE ROAD JUNCTION (L) AND POTHOLE IN A JOINT (R)

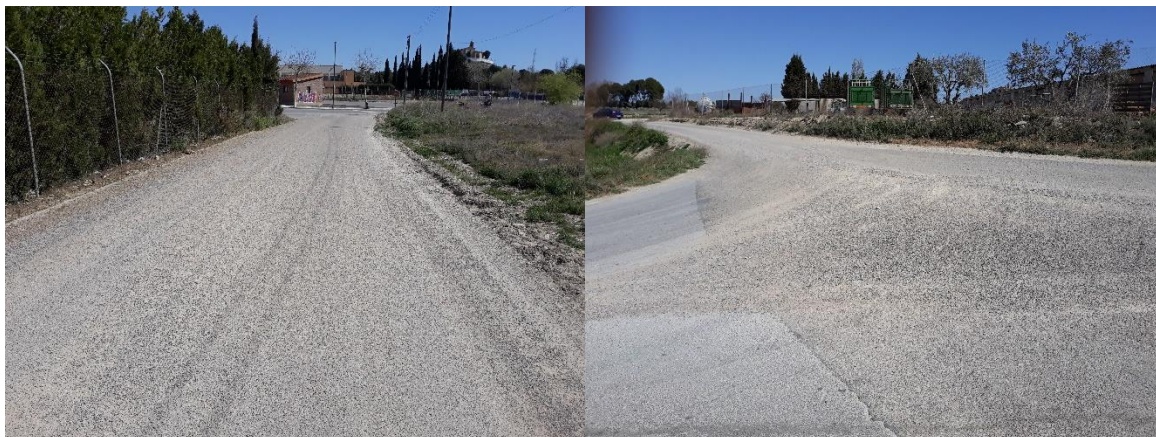
FIGURE 27. END OF ROAD (L) AND DETAIL OF LOOSE AGGREGATES ACCUMULATION (R)

- The loose aggregates were not found. Maintenance works by the The municipality conducted some maintenance works to remove them. Regular traffic also eliminated most of them.
- Some potholes were enlarged due to traffic activity.
- A trench was excavated through the road creating a lack of integrity at PK 0+250.
- Some incipient regular cracks (each 4 m) were observed in the cement stretch as a consequence of the high and quick rigidity developed by cement.

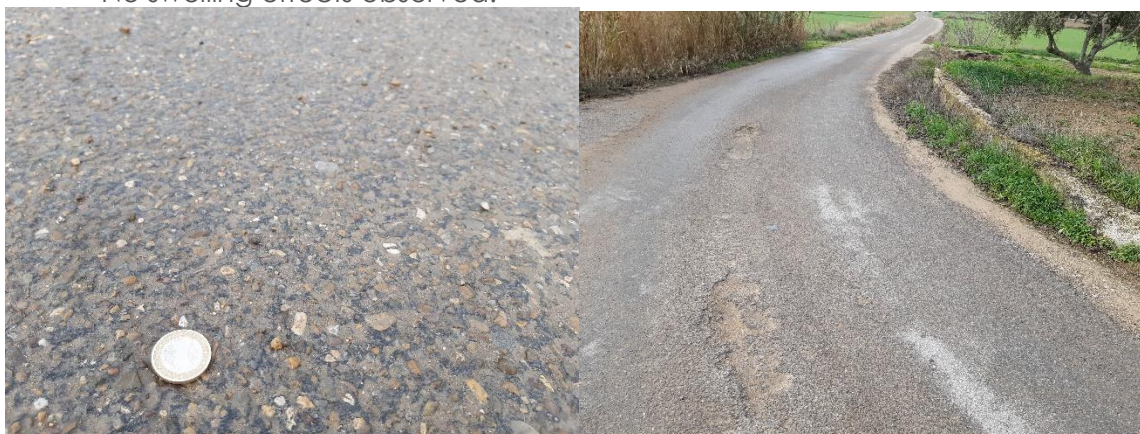
FIGURE 28. DRESSING INTEGRITY (L) AND POTHOLE IN THE JOINT (R)

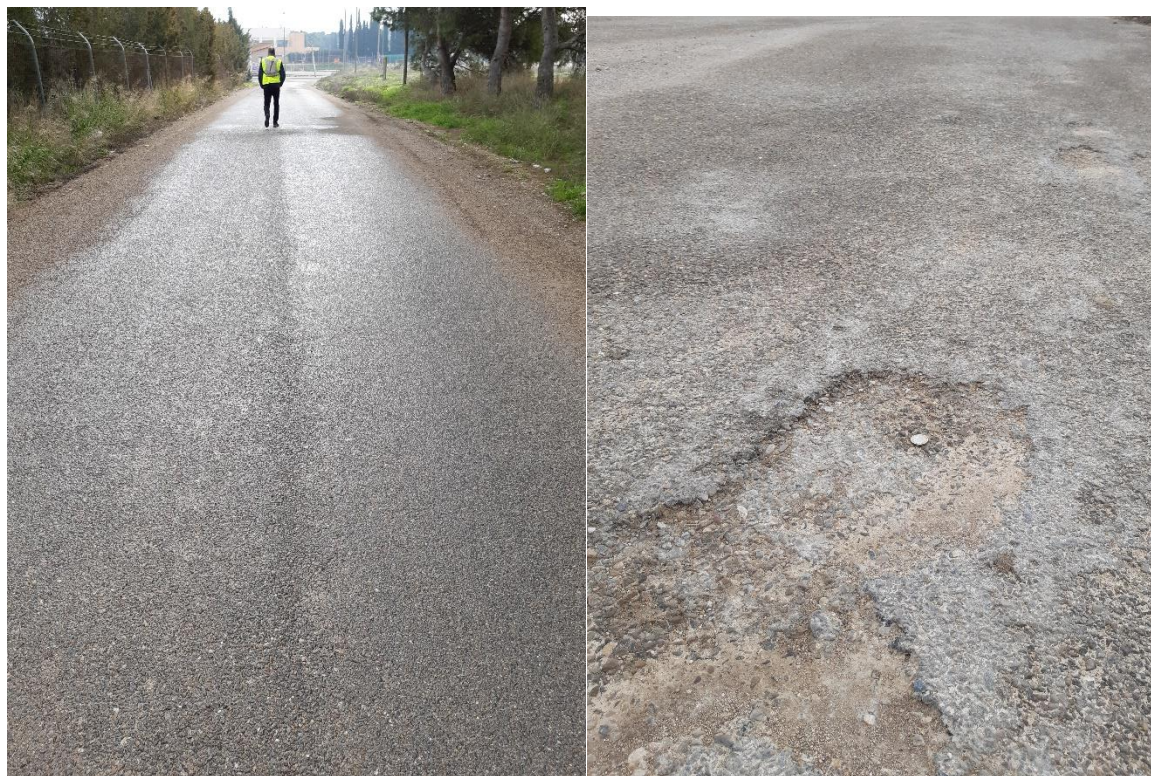
FIGURE 29. EXCELLENT ROAD INTEGRITY IN THE WPA STRETCH (L). POTHOLES IN THE JUNCTION (R)

- No cracking was observed in the WPFA stretch due to the lower rigidity deployed by WPFA and the slower strength development.
- No swelling effects observed.

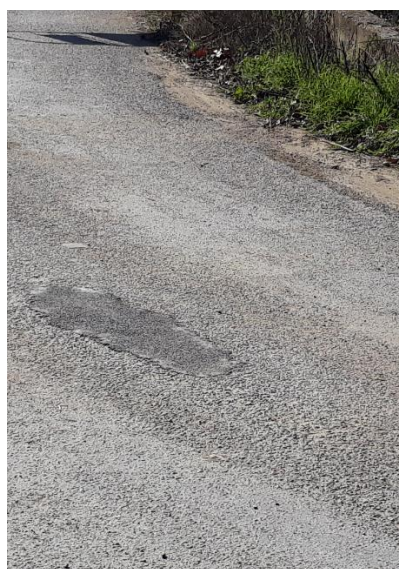
FIGURE 30. EXAMPLE OF POT REPAIRATION

All the potholes were repaired with cold pavement in order to preserve the road integrity to be able to observe any malfunction due to the WPFA.

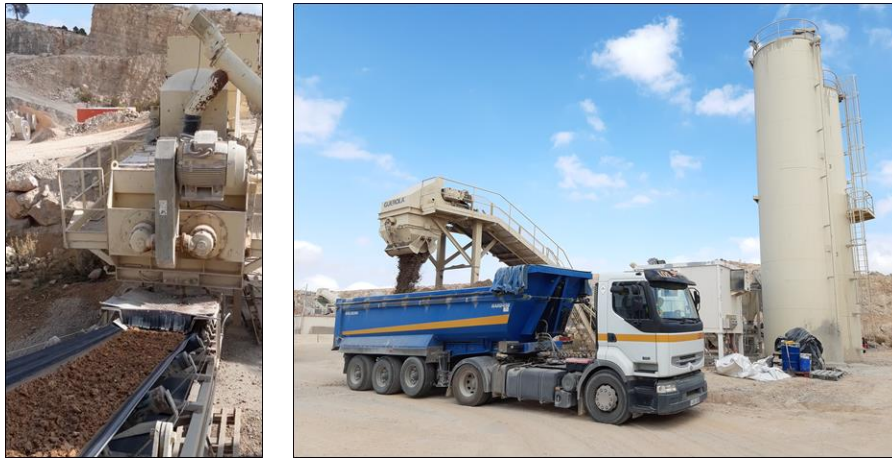
FIGURE 42. SOIL-CEMENT PLANT: ASH-SOIL DETAIL ON CONVEYOR BELT AND TRUCK LOADING

Previously, a silo of the soil-cement plant was loaded with fly ash and dosing tests were completed with this additive. Relevant adjustments were made in the plant to achieve the material with the required working formula since as ash has a lower bulk density than cement and the greater dosage. In total, 105 tons of fly ash were employed in the demonstrator.

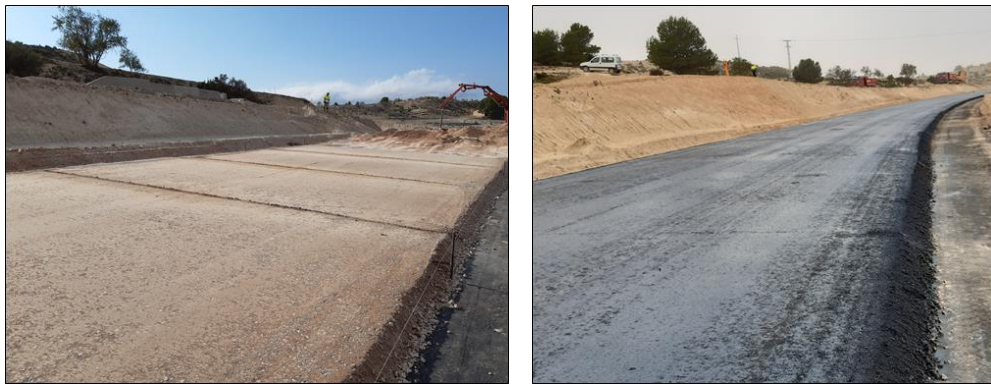
FIGURE 43. APPEARANCE OF THE PRE-CRACKING TEST SECTION (LEFT) AND THE PILOT COVER CURING EMULSION (RIGHT)

The layer was transversely pre-cracked with saw every 3.5m after compaction. Forced fissures were sealed with bituminous emulsion and the surface was protected with a bituminous curing coat.
